Macan Electric (XAB) – AC Charging at Home Not Possible after WSJO

Vehicles Affected

Model	Model Year	Model Type	Vehicle-Specific Equipment
Macan Electric (XAB)	2024-2025	All	N/A

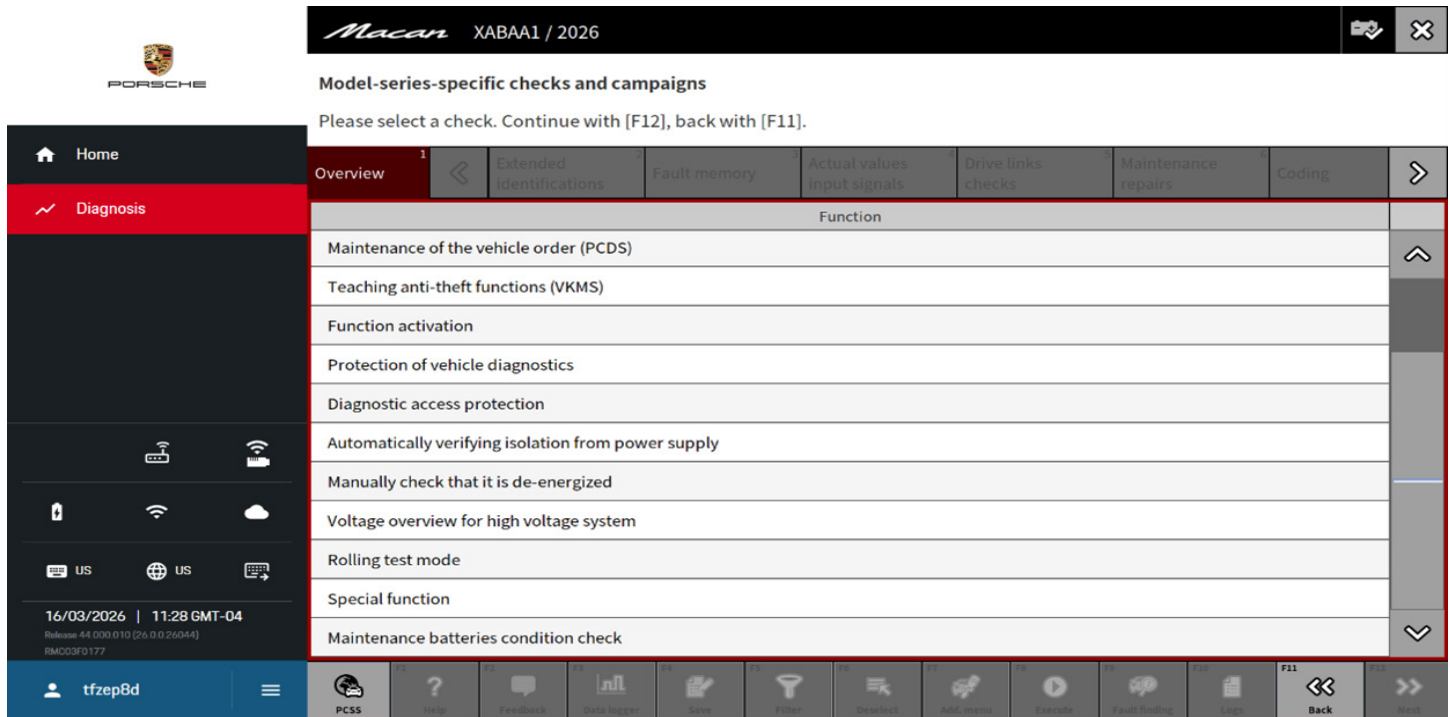
5. Use the Special Functions Tab of the Additional Menu [F7] to begin the programming procedure.
6. Read and follow the information and instructions on the PIWIS Tester during the guided programming sequence. A VAL will automatically be created after the programming is completed.

7. Verify the SW level is changed to 0346
8. Verify that the vehicle is still able to AC Charge at the workshop

Note: After following this procedure, an optional update will be available for the High-Voltage Central Box. This update must not be completed.
